Composite Materials in Aircraft Mishaps Involving Fire: A Literature Review

Howard L. Bowman, Ross A. Davidson,
and Eric J. Gogley
Engineering Sciences Division
Research Department
Naval Air Warfare Center Weapons Division, China Lake, California

NAWCWD Technical Publication 8552

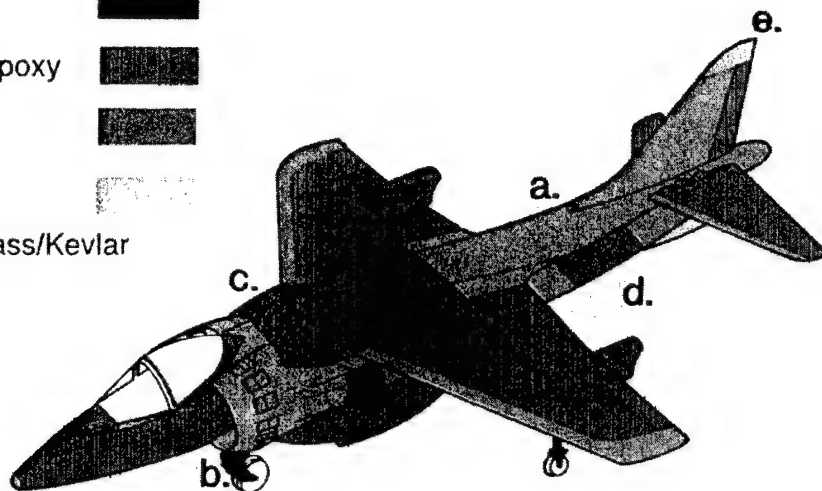
FIGURE 1. Composite Locations on an AV-8B Harrier.

Advanced composite materials are used in many different locations in both commercial and military aircraft. Typical areas of usage include engine cowlings, flaps, floor panels and beams, undercarriage doors, leading edges, trailing edges, gunpacks, stabilizers, nosecones, rudders, wing skins, ailerons, ducting, landing gear doors, and radomes (References 7 and 12). Figure 1 shows an AV-8B Harrier with composite material locations identified (Reference 13).

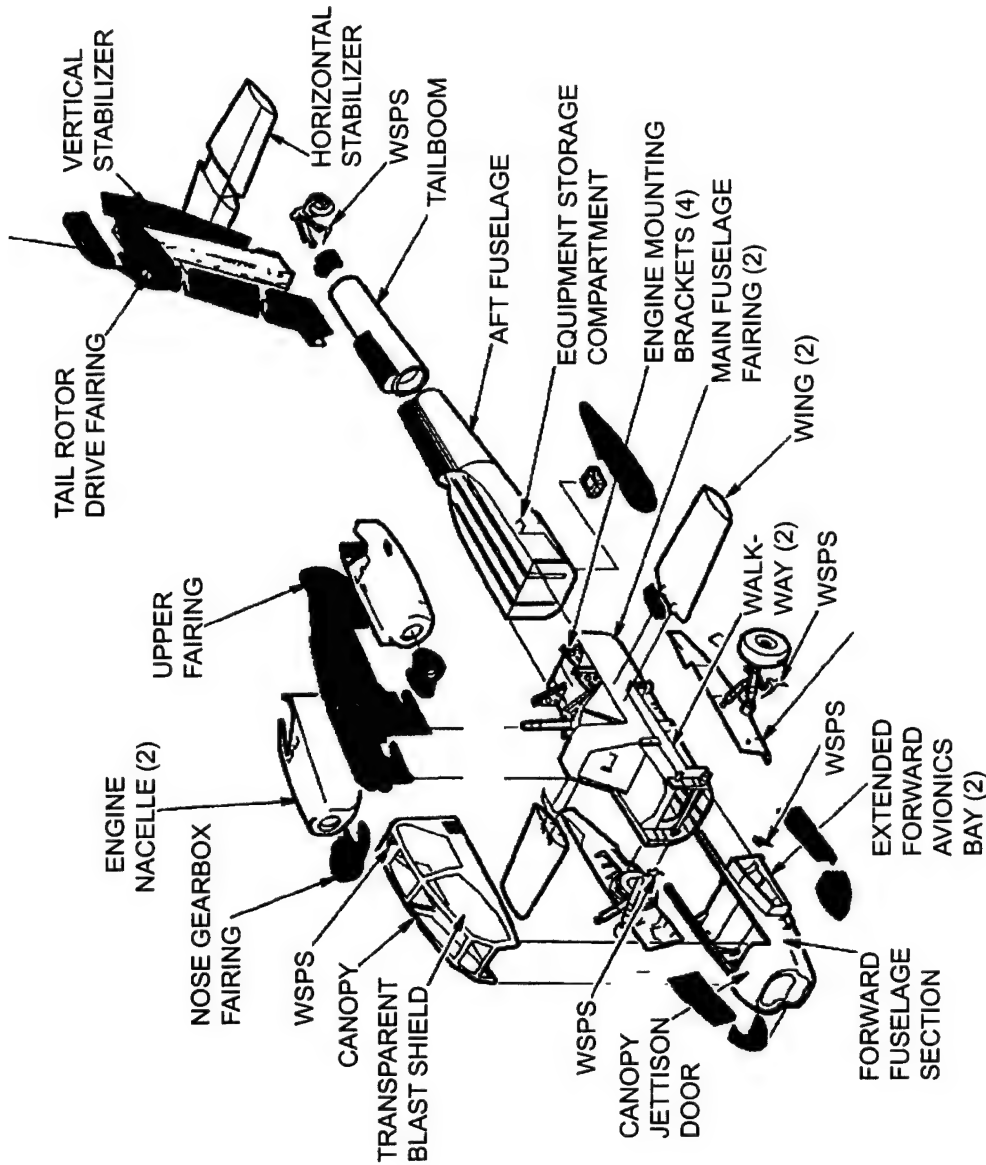
AH-64D**AIRFRAME MATERIALS****1. AIRFRAME MATERIALS**

- a. Main Rotor Blades (not pictured) are constructed of stainless steel, aluminum, fiberglass, and nomex honeycomb.
- b. Cockpit flooring (not pictured) is constructed of Boron armor.
- c. Crew seats (not pictured) are constructed of Kevlar/Boron carbide and nylon.
- d. Tail Rotor hub forks (not pictured) are constructed of Titanium.
- e. Both aircraft engines (T700-GE-701-C) are constructed with Titanium/Carbon/Nickel Graphite.
- f. Battery (not pictured), located on the right side is a Fiber Nickel-Cadmium battery.

- Graphite Composite
- Kevlar/epoxy Composite

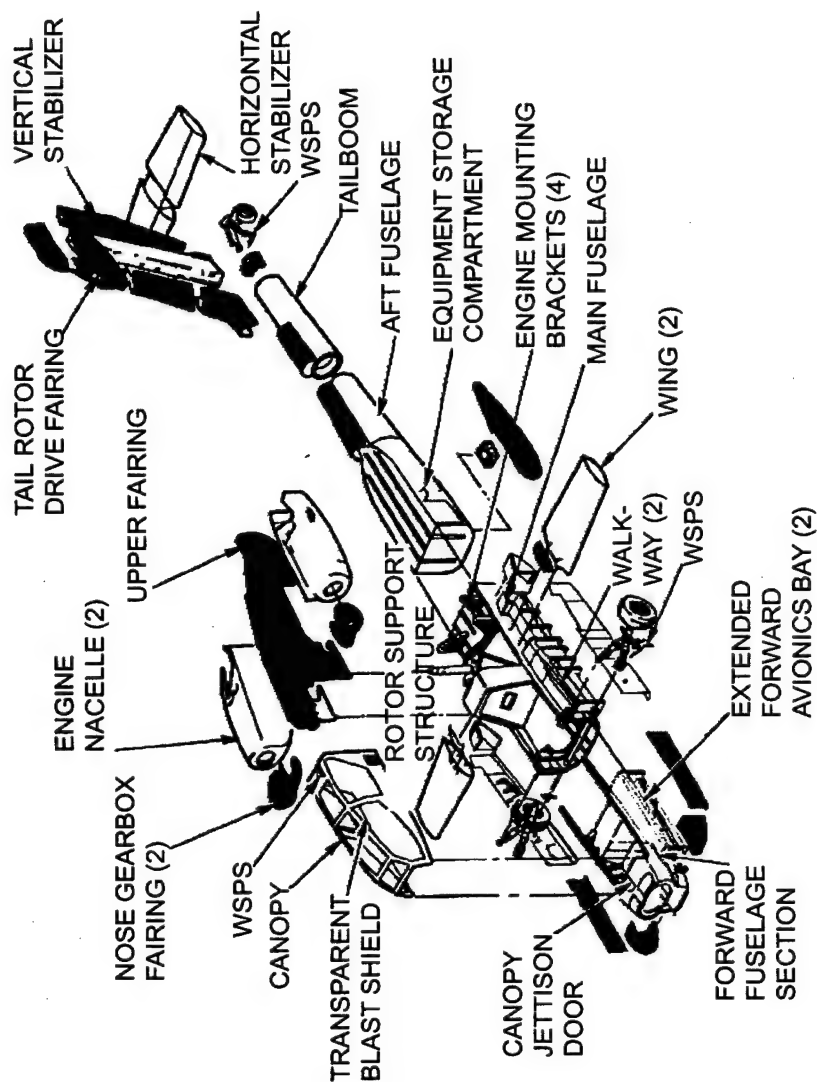
AIRFRAME MATERIALS

- a. Aluminum
- b. Carbon/Epoxy
- c. Carbon/Kevlar/Epoxy
- d. Glass Fiber Reinforced Plastic
- e. Kevlar/Foam Core
- f. Kevlar/Nomex
- g. Carbon/Nomex

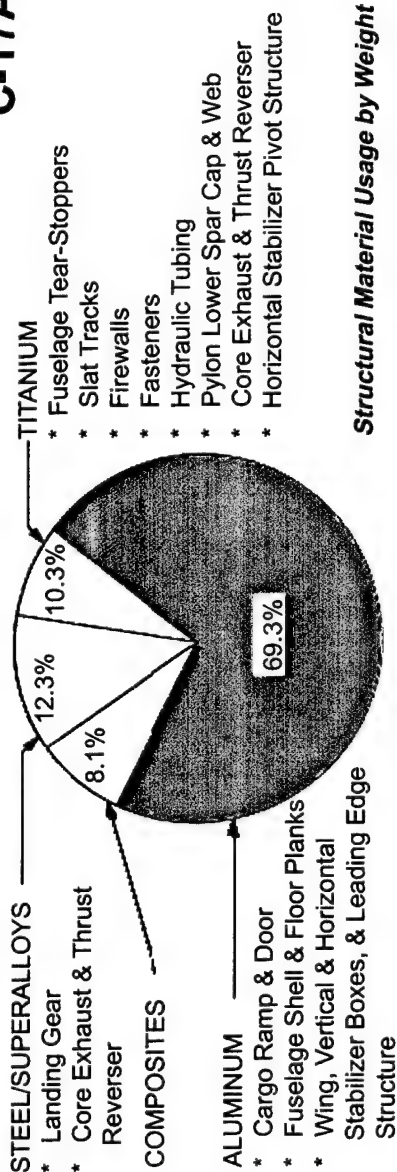
C-17A

The fuselage and wing are constructed primarily of aluminum alloy material. However, aluminum-lithium, titanium, steel, and composite materials are used wherever there are cost-effective advantages in weight, fatigue life, or corrosion resistance.

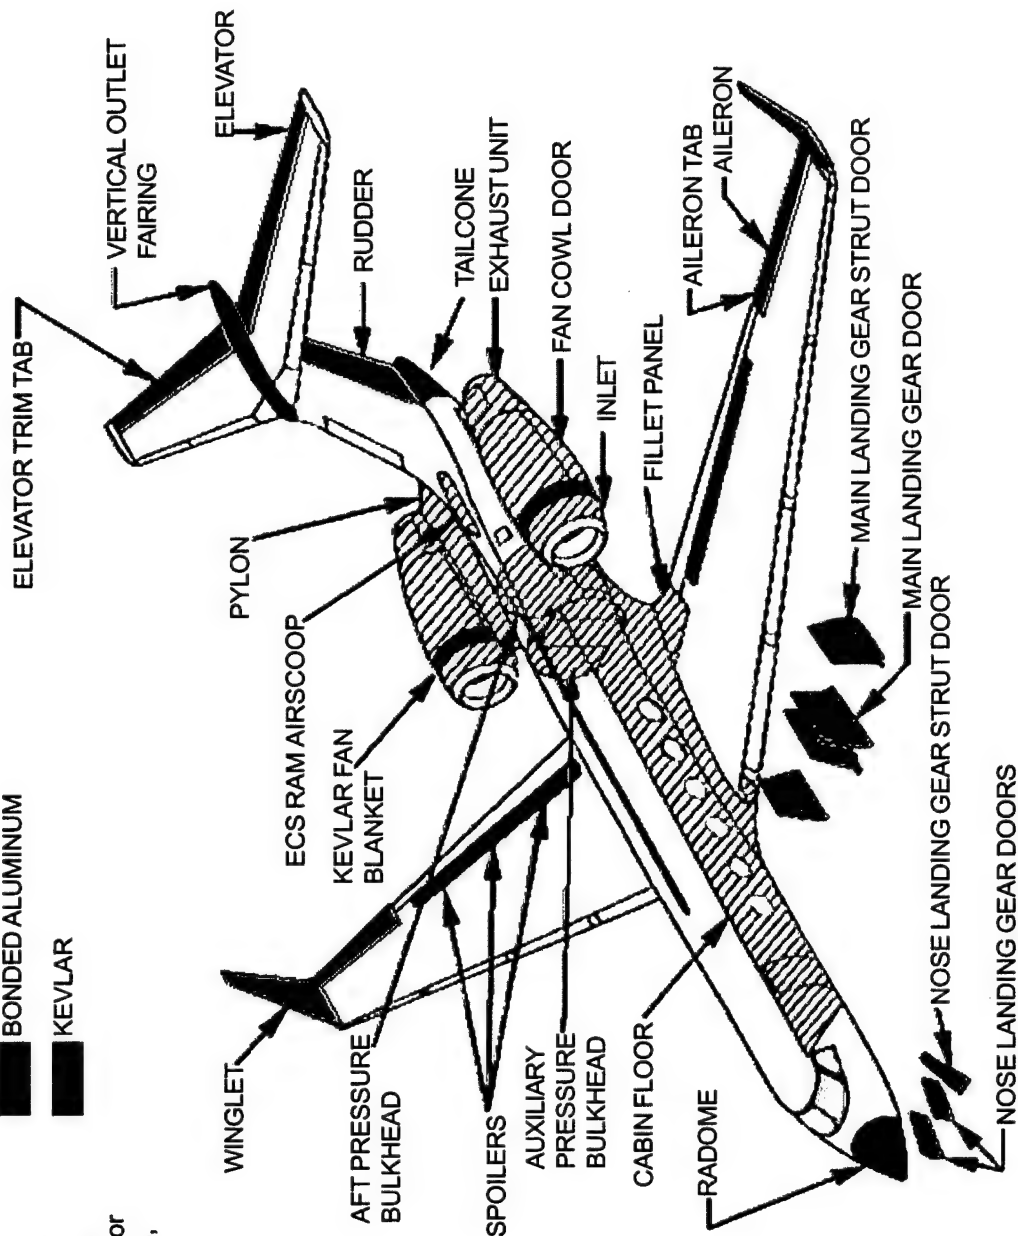
C-38A**COMPOSITE MATERIALS**

Composite materials are used extensively on this aircraft (Gulfstream V) to save weight and increase strength. Composite materials include metallic and non-metallic structures for bulkheads, doors, flight controls, floor panels, fairings, nacelles, panels, pylons, radome, tailcone, and winglets.

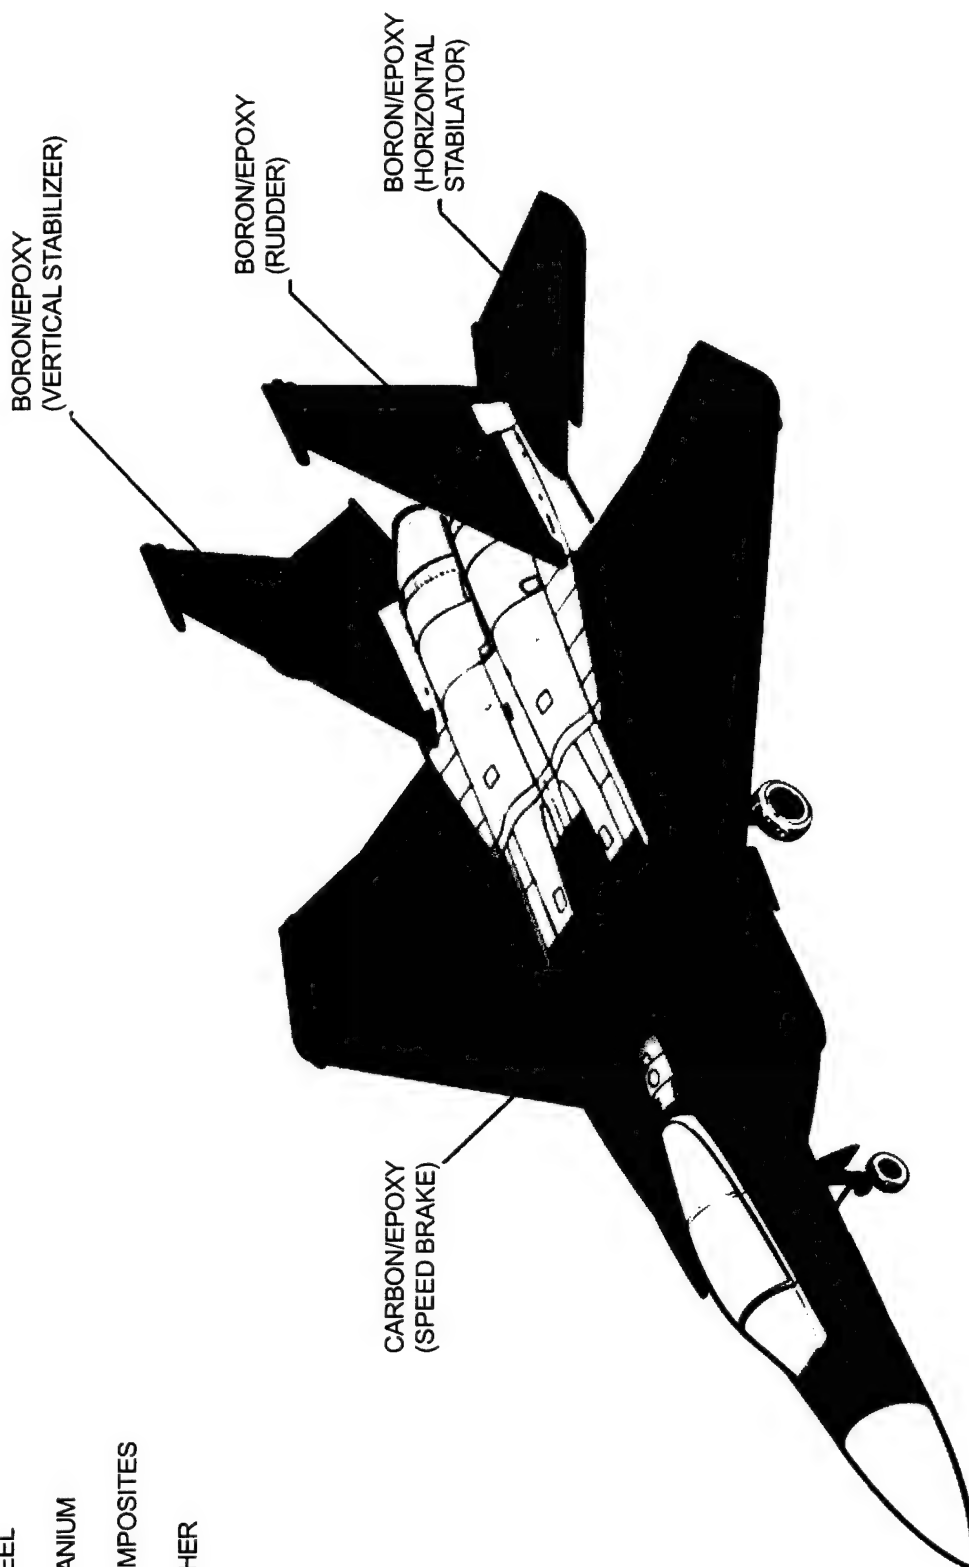
F-15

COMPOSITE/MATERIAL DISTRIBUTION

■	ALUMINUM.....	37.3%
□	STEEL.....	5.5%
■	TITANIUM.....	25.8%
■	COMPOSITES.....	1.2%
■	BORON.....	
■	GRAPHITE.....	
■	FIBERGLASS.....	1.0%
■	OTHER.....	29.2%
■	HONEYCOMB.....

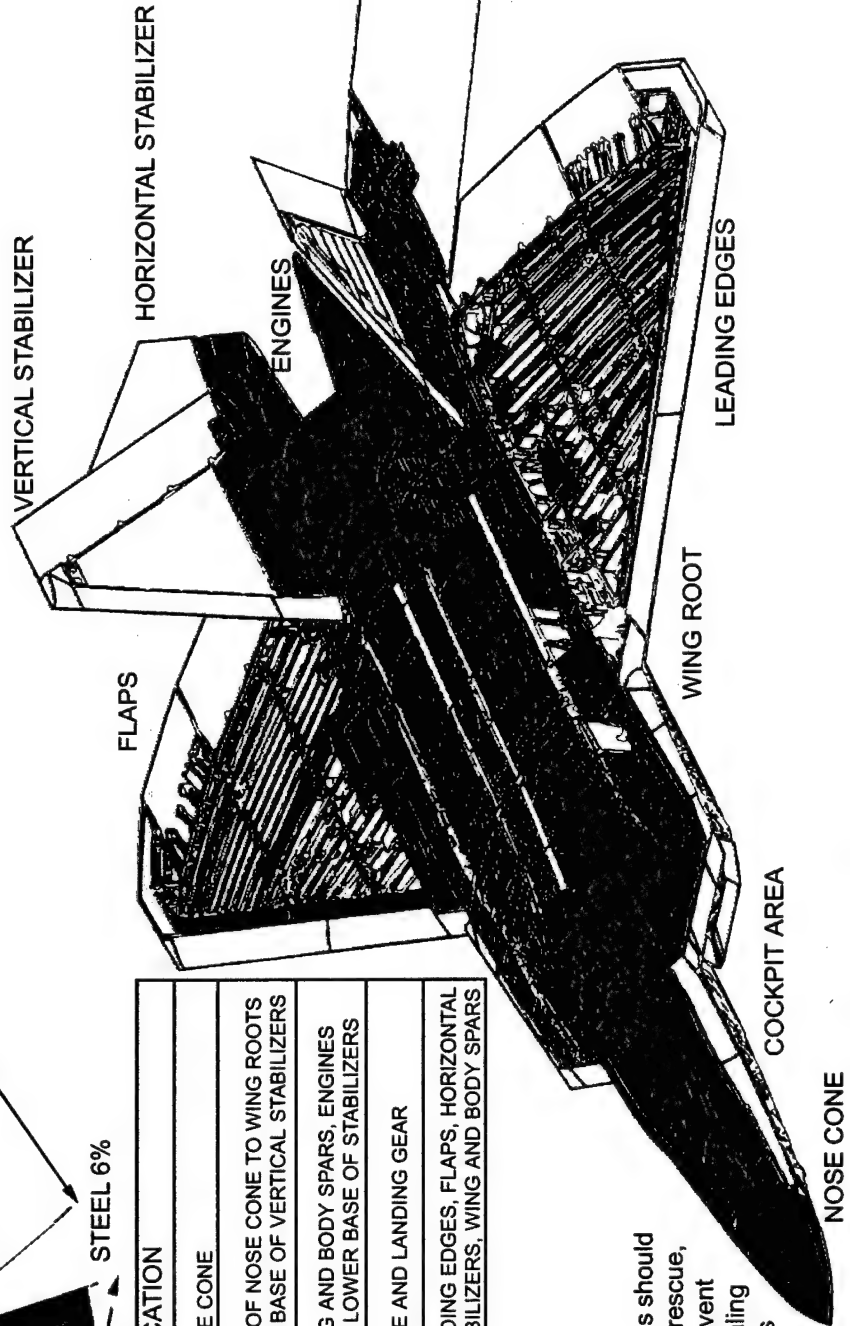
F-22A

Organic composite structural laminates are made up of stacks of oriented thin lamina that consolidated under heat and pressure. Each lamina consists of a layer of high-strength, high-modulus, low-density reinforcing fibers embedded in a resin matrix. Fibers typically are materials such as carbon, boron, Kevlar 49, or fiberglass. The matrix can be either a thermosetting material such as epoxy, bismaleimide, or polyimide, or a thermoplastic material. If the matrix is thermosetting, a solid material is formed that cannot be reprocessed. Thermoplastic materials, however, can be reshaped by reheating and reforming.

MATERIALS LOCATION	
OTHER	NOSE CONE
ALUMINUM	AFT OF NOSE CONE TO WING ROOTS AND BASE OF VERTICAL STABILIZERS
TI 6222 (TITANIUM) TI 6-4 (TITANIUM)	WING AND BODY SPARS, ENGINES AND LOWER BASE OF STABILIZERS
STEEL	NOSE AND LANDING GEAR
THERMOPLASTICS (COMPOSITES) & THERMOSETS (COMPOSITES)	LEADING EDGES, FLAPS, HORIZONTAL STABILIZERS, WING AND BODY SPARS

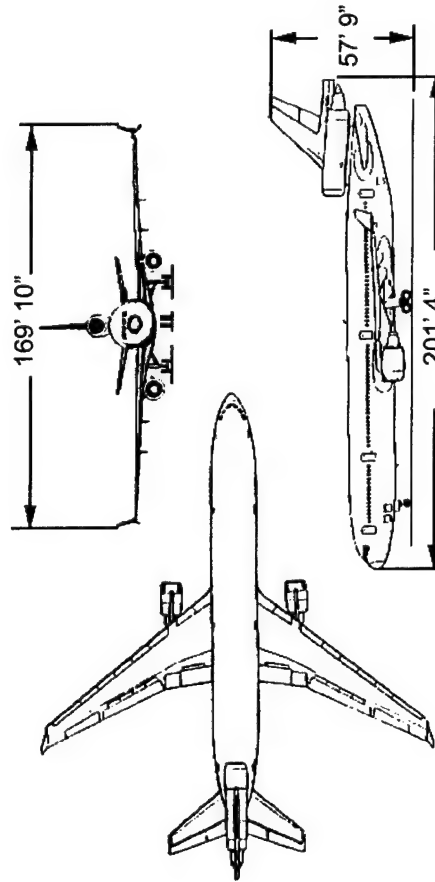
MD-11

4. MD-11F is a all-freighter version.
5. MD-11C&D are tentatively planned for increased capacity.
6. **AIRCRAFT STRUCTURE**
Composites used in virtually all control surfaces, engine inlets and cowlings, and wing/fuselage fillets; wing has two-spar structural box with chordwise ribs and skins with spanwise stiffeners; upper winglet of ribs, spars and stiffened aluminum alloy skin with carbonfibre trailing edge; lower winglet carbonfibre; inboard ailerons have metal structure with composites skin; outboard ailerons all composites; inboard flaps composites-skinned metal; outboard flaps all-composites; spoilers aluminum honeycomb and composites skin; tailplane has CFRP trailing edge; and elevators CFRP.

NOTE:
AIRCRAFT DIMENSIONS
Length 201' 4"
Wing Span 169' 10"
Height 57' 9"

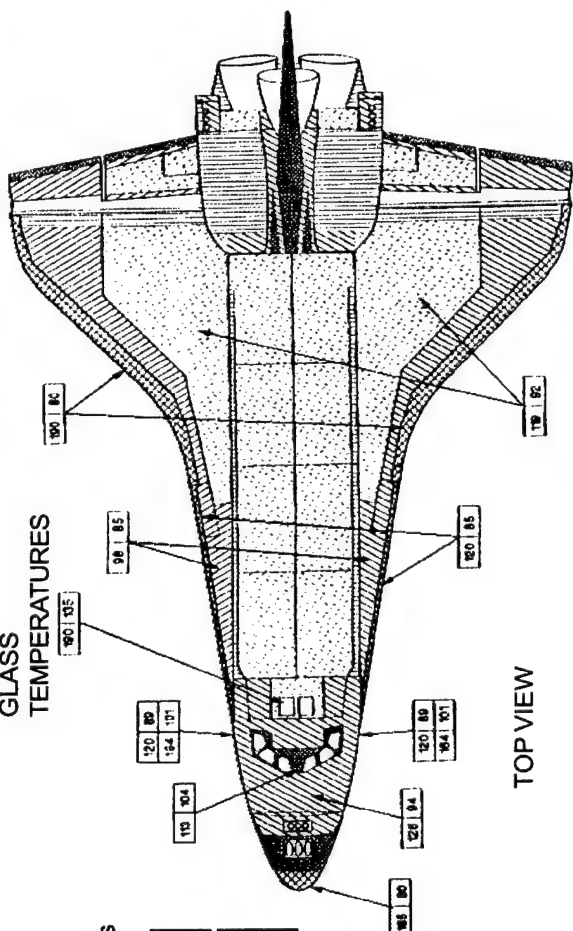
TOP VIEW

GLASS TEMPERATURES

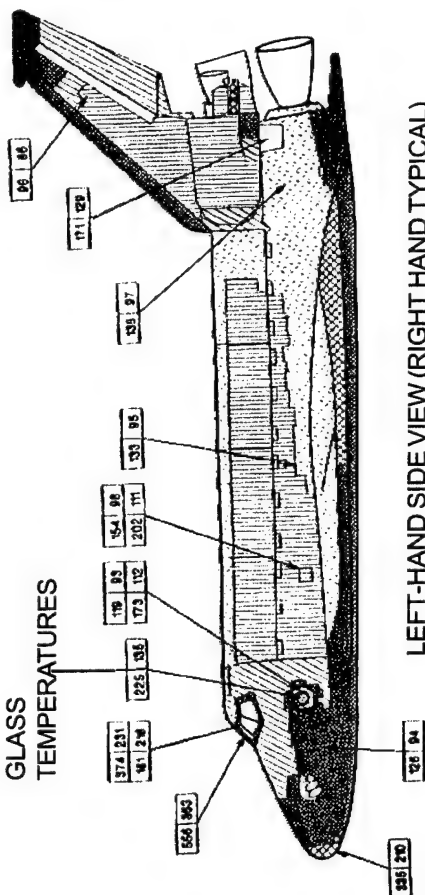
LEFT-HAND SIDE VIEW (RIGHT HAND TYPICAL)

GLASS TEMPERATURES
